CDF Operations Report

All Experimenter's Meeting
August 21, 2006

ISL Cooling Problem

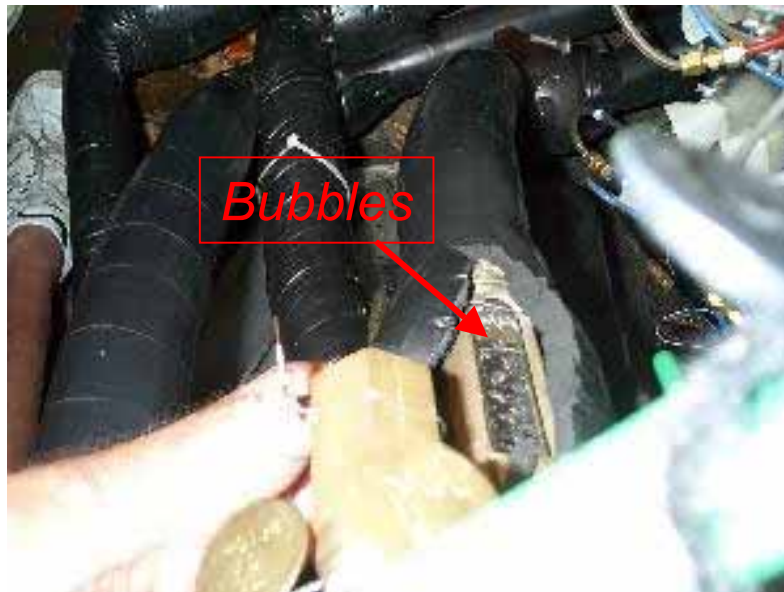
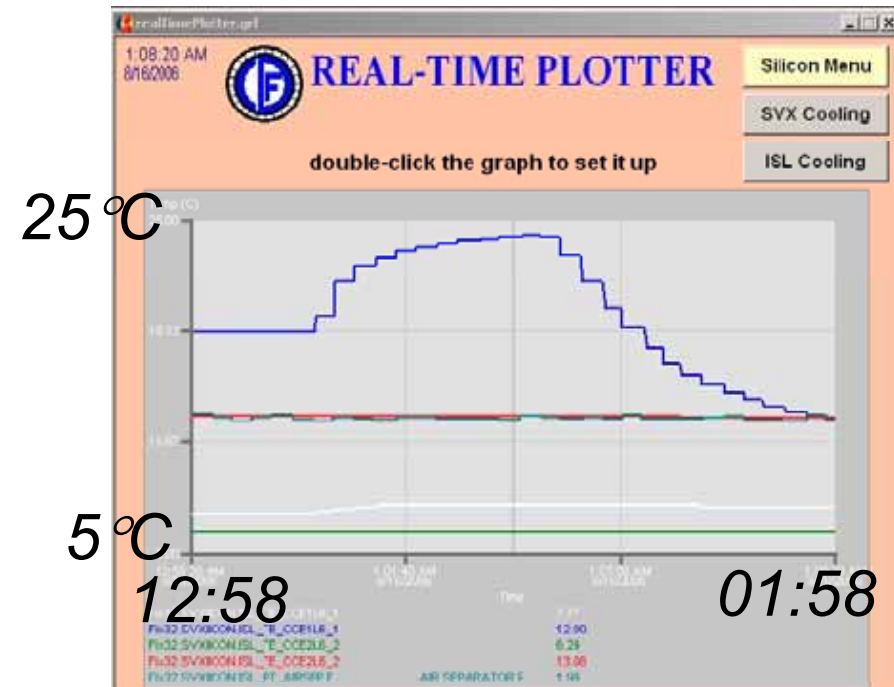
- Observed bubbles in Silicon cooling water few weeks ago.
 - Could be the cause of compromised cooling in sections of Silicon.

- Temperature rise in part of Silicon detector on Wed Owl.
 - Possibly a big bubble went in.
- Interlock failed to trip HV for 1 wedge out of 6.
 - No damage to our detector, fortunately.
 - The part of detector in question was fed with another cooling line.
 - Fixed the jumper on power supply in wrong position during access.

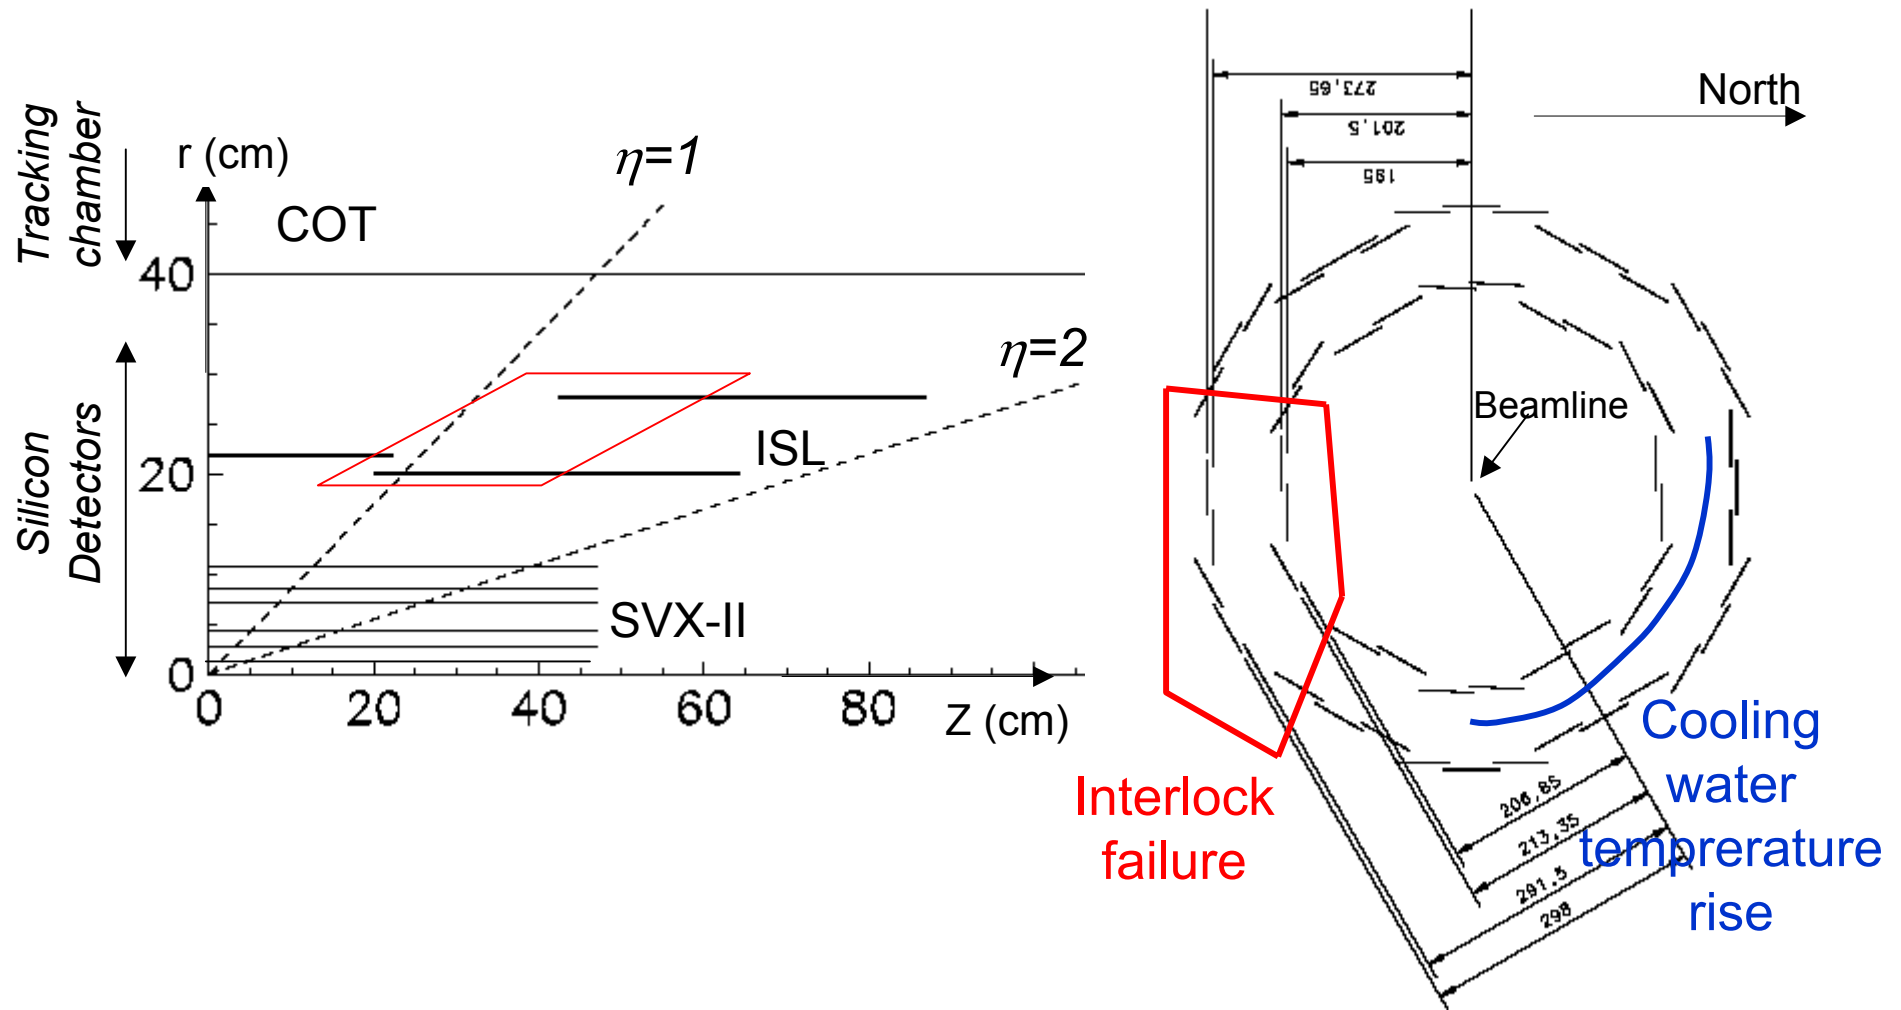
Silicon Cooling Interlock Failure

- The warmed cooling water fortunately did not serve the section of detector.
